# **Warm Springs Run Stream Corridor Assessment**

**Kieran O'Malley**

**Commissioned by the  
Morgan County Purple Loosestrife Task Force**

**October, 2007**

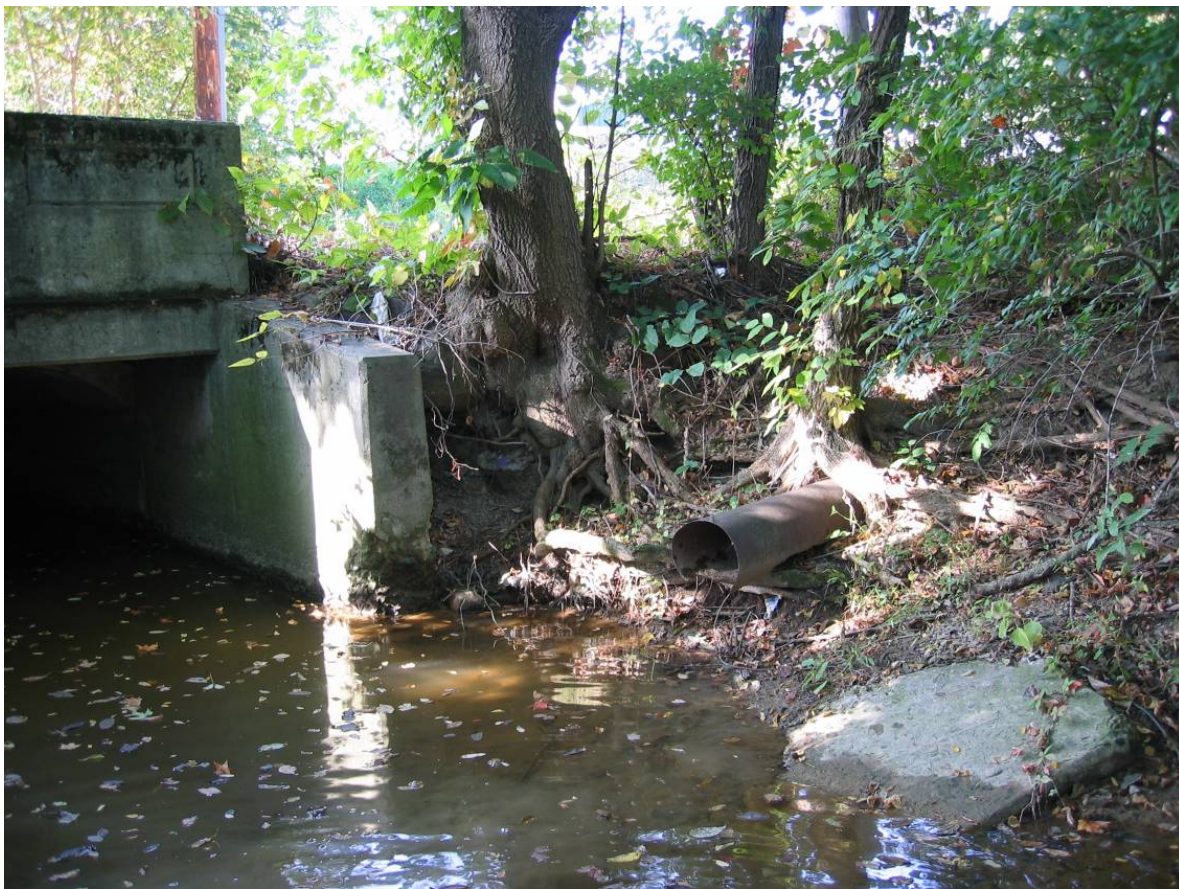
**Figure 3. Numerous pipes empty into Warm Springs Run, a highly impaired stream.**

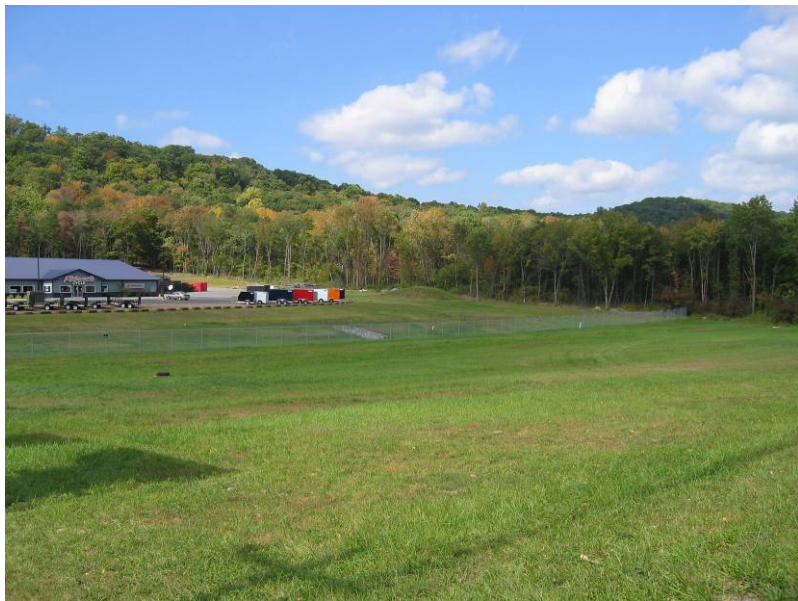
**Figure 5. Inadequate riparian buffer in the headwaters of Warm Springs Run.**

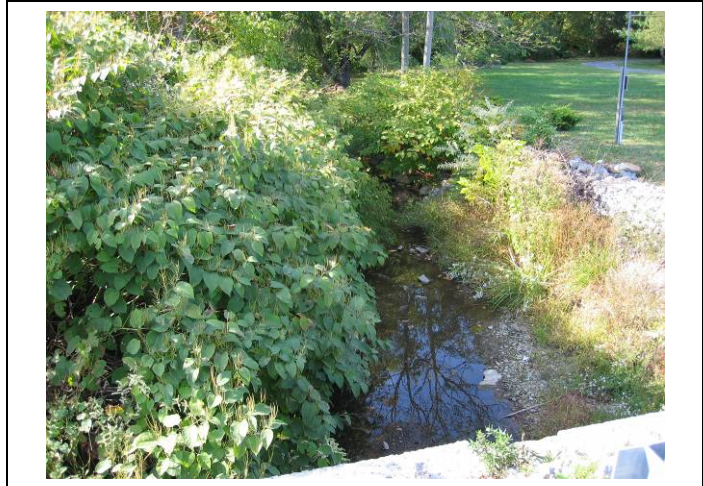
**Figure 6. Japanese knotweed stand upstream near the intersection of US 522 and Winchester Grade Road.**

Six species were documented in this section (Table 6). Japanese knotweed forms monotypic stands along more than 90% of this section (Figure 6). autumn olive, multiflora rose, and tree of heaven were found growing in small gaps in the Japanese

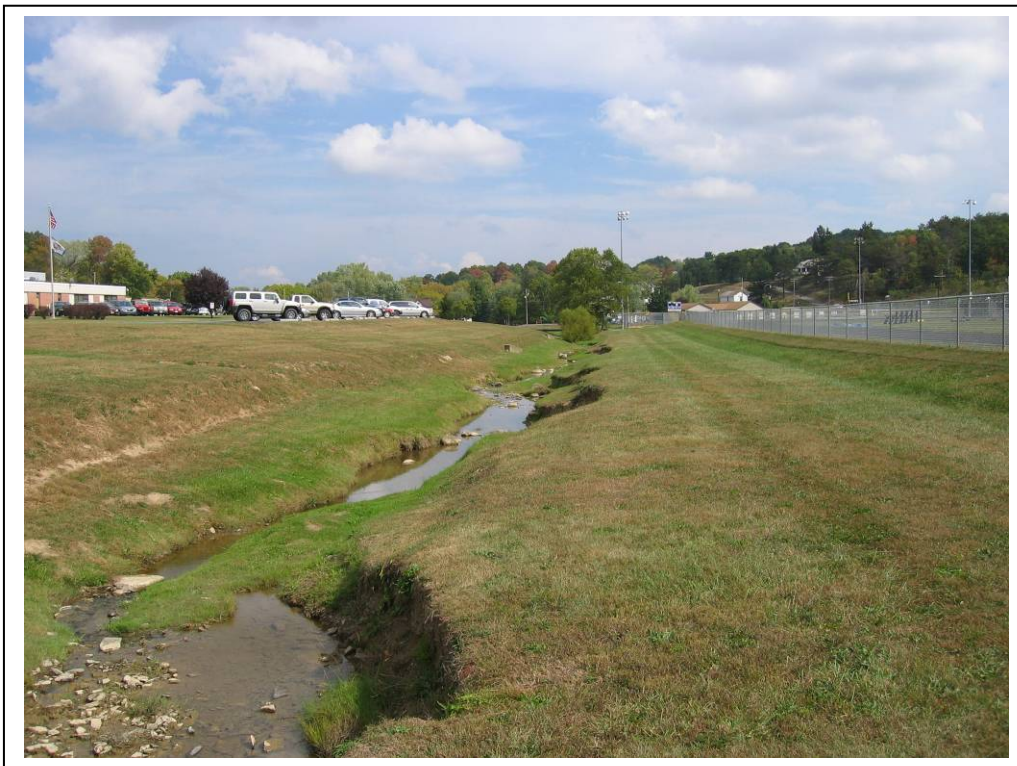
In this section Warm Springs Run flows through an urban area with commercial and residential development. The riparian zone is eliminated in intensively developed areas (e.g. neighborhoods). Where a floodplain is present, nine properties were identified that had impaired or inadequate buffer zones. Extreme examples of inadequate riparian buffers include Widmyer Elementary School and Berkeley Springs High School (Figure 7).

**Figure 7. Inadequate riparian buffer at Widmyer Elementary where the stream divides the school property.**

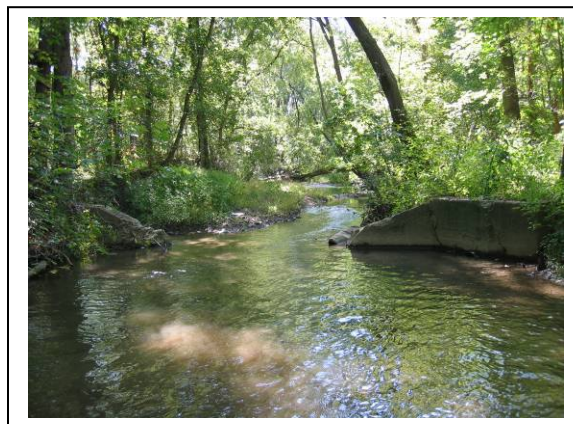
This section contains channelized stream bank, two flood sluices (weirs?), and the Jimstown Road bridge (Williams Street bridge was described in the previous section). At the Williams Street bridge, both banks are rip rapped for about 200 feet. The two flood sluices or weirs are about 200-300' apart (Figure 8). They appear to direct the current towards the center of the stream channel and cause the creek to become entrenched immediately downstream. Jimstown Road crosses the creek on a single bridge span and constriction is relatively minor.

**Figure 8.** A flood sluice or weir north of Berkeley Springs.

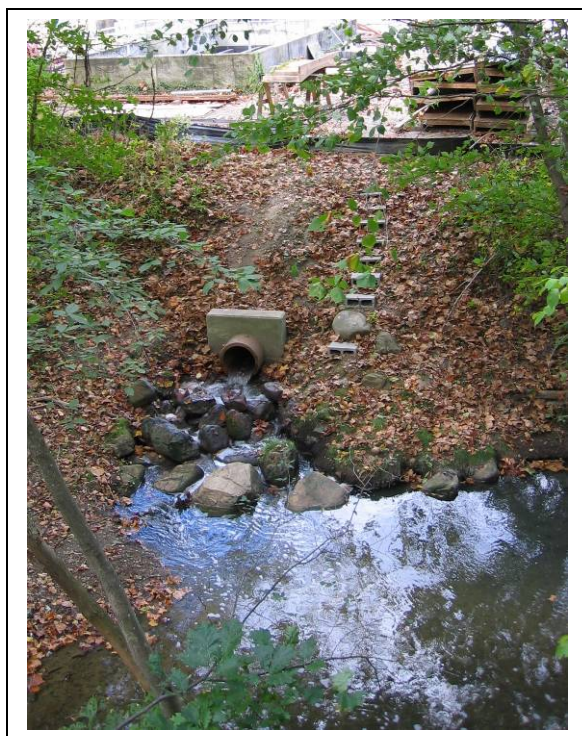
Two pipe outfalls were documented at the Berkeley Springs waste water treatment plant. One pipe appears to be a new discharge pipe for the plant and was not active. The second pipe appeared to be the active discharge pipe (Figure 10). This site was visited twice (to take photographs) and it was discharging into Warm Springs Run on both occasions.

**Figure 10.** Active discharge from the waste water treatment plant.

Beginning at the waste water treatment plant and continuing through this section, pools in the streambed contain pockets of dark sludge that emit a strong sewage smell when disturbed.

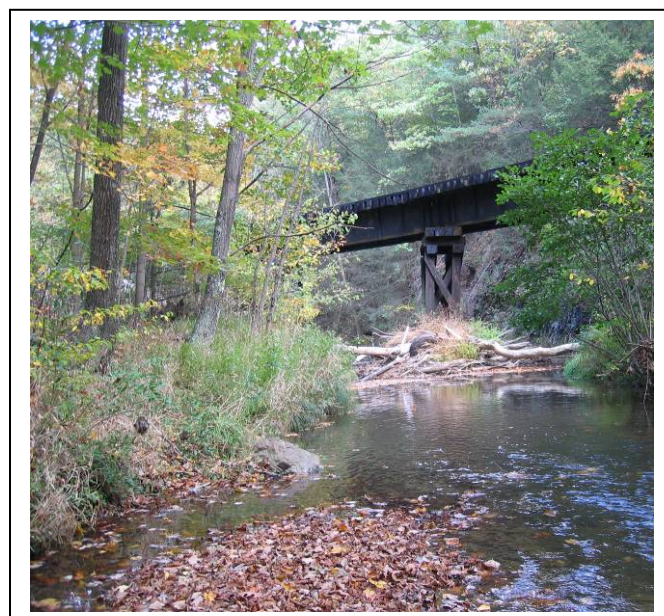
**Figure 11.** Debris jam and channel alteration caused by the railroad bridge in Section 7.

Railroad hardware (spikes, metal plates, ties) was found under several bridges. Large debris jams occurred when bridge piers were located in the streambed. Large trees and logs floating downstream collect at the piers and they subsequently collect more debris.

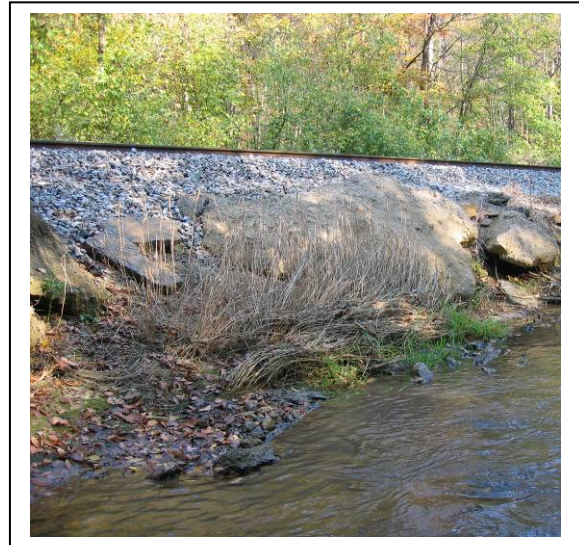
Seven locations with an inadequate riparian buffer were identified. Several sites along the railroad tracks are also experiencing erosion problems. At locations where the stream and the railroad grade run parallel, the vegetation between the grade and bank has been killed with herbicide.

**Figure 12. Herbicide used along the railroad to control riparian vegetation.**

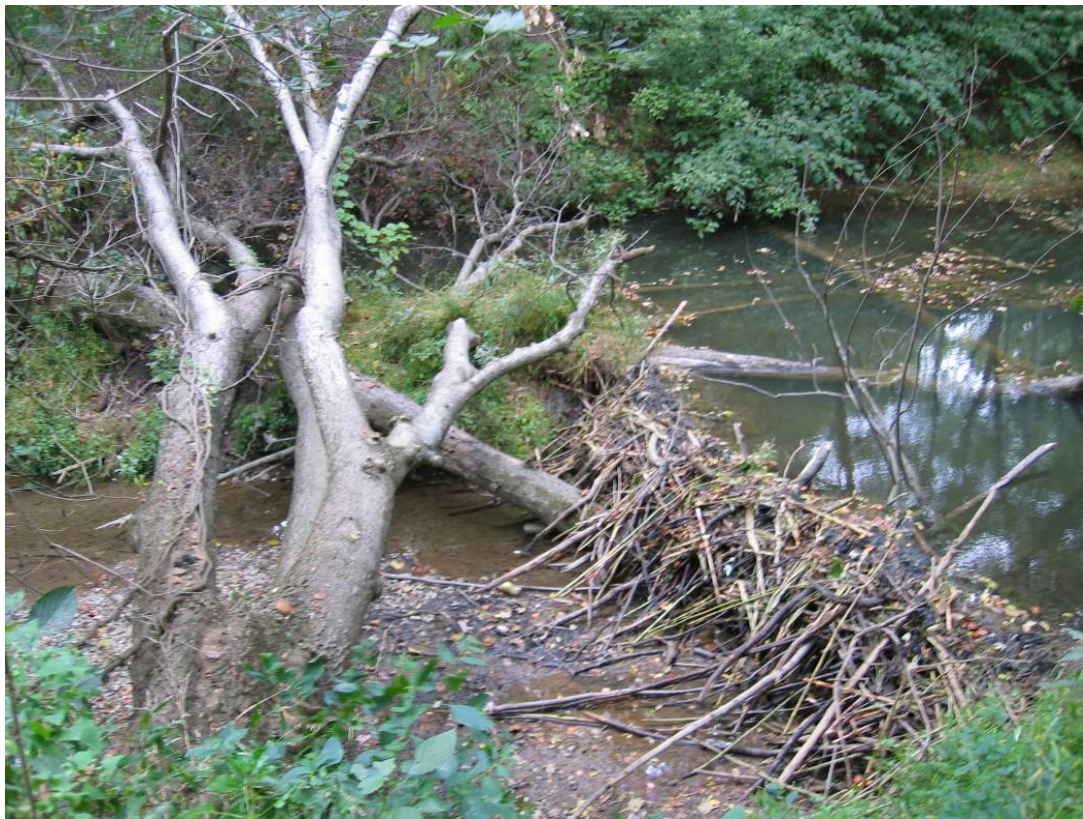
**Figure 13. Beaver dam near the mouth of Warm Springs Run.**
