# **WARM SPRINGS RUN WATERSHED ASSESSMENT**

**Morgan County, West Virginia**

**December 2010**

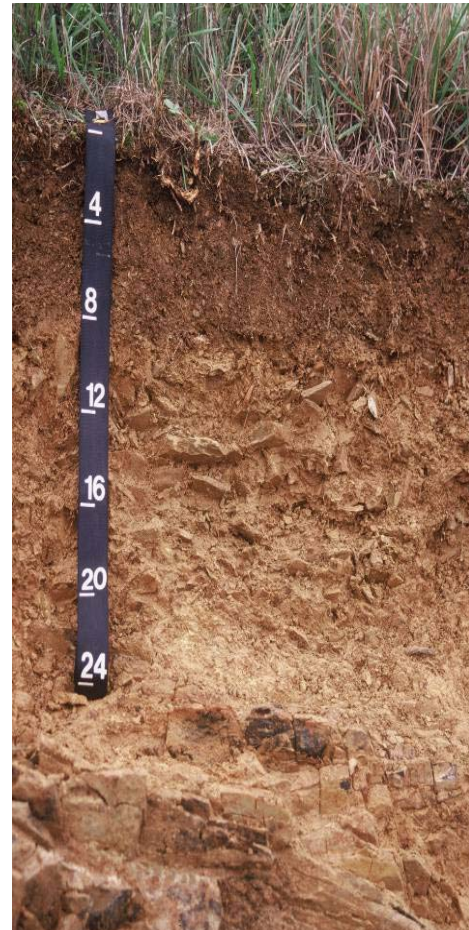
**Figure 2:** Weikert silt loam soil

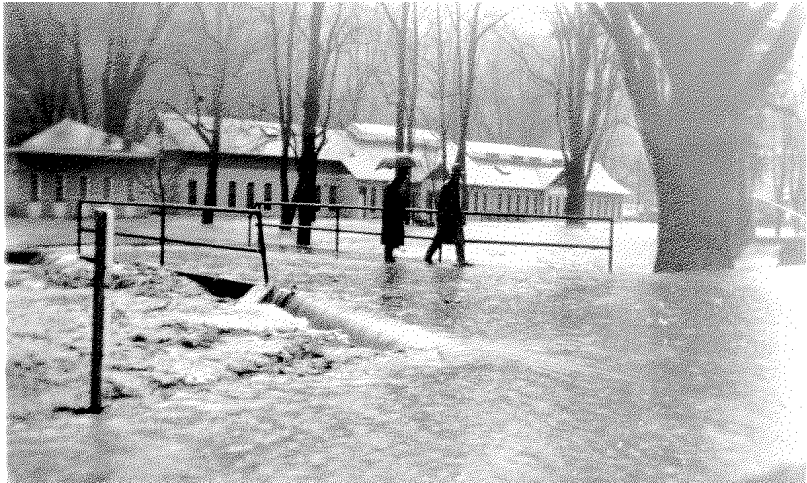
**Figure 11:** 1939 flooding in Berkeley Springs State Park

Many of the homes and businesses in the floodplain reported water in their basements. Stores in the main part of town used sand bags or other temporary dikes to keep water out of their first floors. Particular attention was given to the situation at the Park View Inn (now known as the Country Inn), where water flooded the basement and heating plant on several occasions. Considerable damage was also done to the Inn's lawn, flowers and shrubbery.

It was also noted that north of the Inn, the town park (now Berkeley Springs State Park), had been covered with silt. The community swimming pool, located just west of the Run, had been damaged during flood events. The town's water supply, taken from the warm springs located in the Park, was contaminated during floods. Roadways were made impassible, and at times were completely washed out.

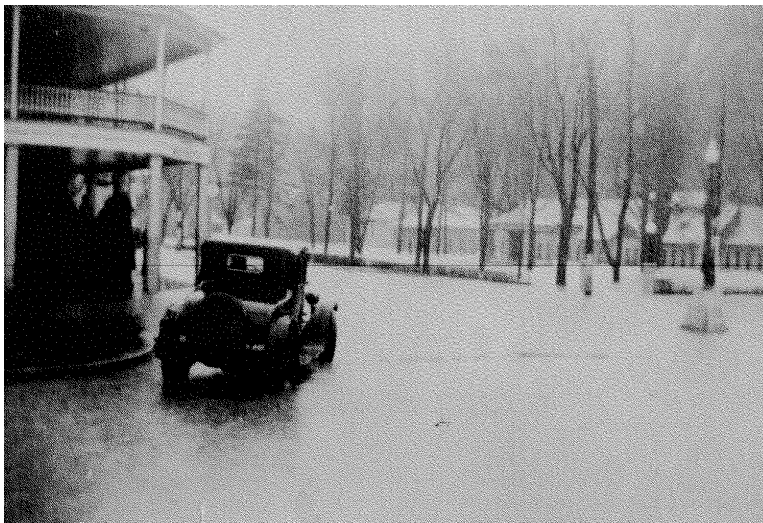
**Figure 12:** Flooding on Fairfax Street, Berkeley Springs

The report estimated that the annual costs incurred due to flooding were \$50,000. In today's dollars that figure would be \$475,000 annually. The damages done by the 1936 flood were estimated to be \$219,948 or calculated to be about \$3 million dollars today.

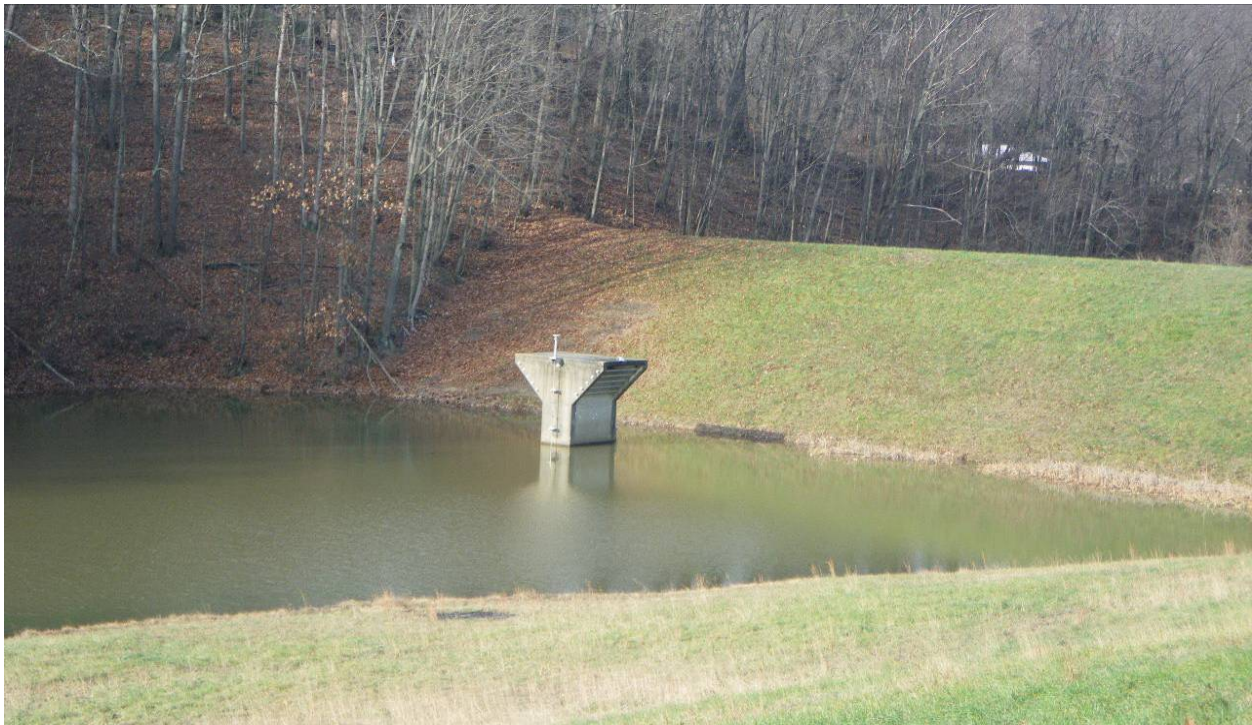
Although the Warm Springs Run Watershed Flood Prevention Dams are fifty years old, they have been well maintained. The structures are reviewed and evaluated twice a year for safety and future program operations by the USDA NRCS, WV Conservation Agency, Eastern Panhandle Conservation District and local project sponsors.

**Figure 13:** Flood control structure

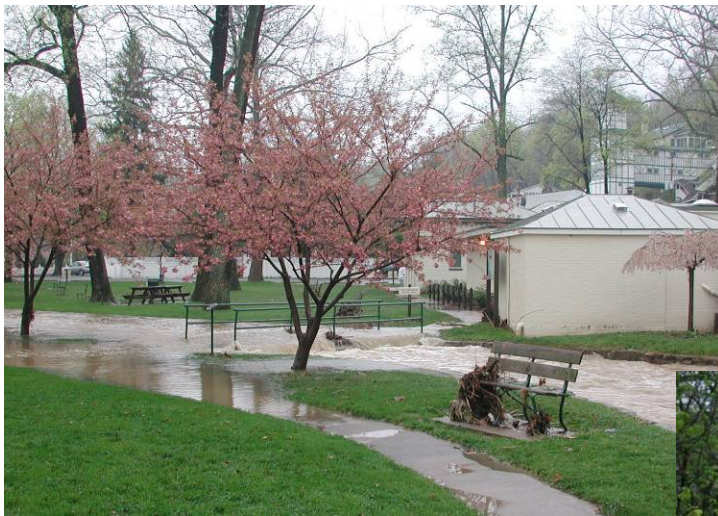
**Figure 14:** 2009 flooding in Berkeley Springs State Park

Flooding in the watershed is still a problem for Berkeley Springs and the Town of Bath. The steep hillsides transmit stormwater quickly into the stream. Major damages have been mitigated by the flood control dams, but clean-up costs, damage to roadways and streambank walls is still significant. In 1991 a supplemental study to the original 1954 report by the USDA Soil Conservation Service proposed additional flood channels be constructed through the Town of Bath. The project was justified by the amount and occurrence of damage to structures in the watershed that had been built since the time of the original study and since less than 20% of the watershed was controlled by the Warm Springs flood prevention dams. The funding for the proposed project was never sought.

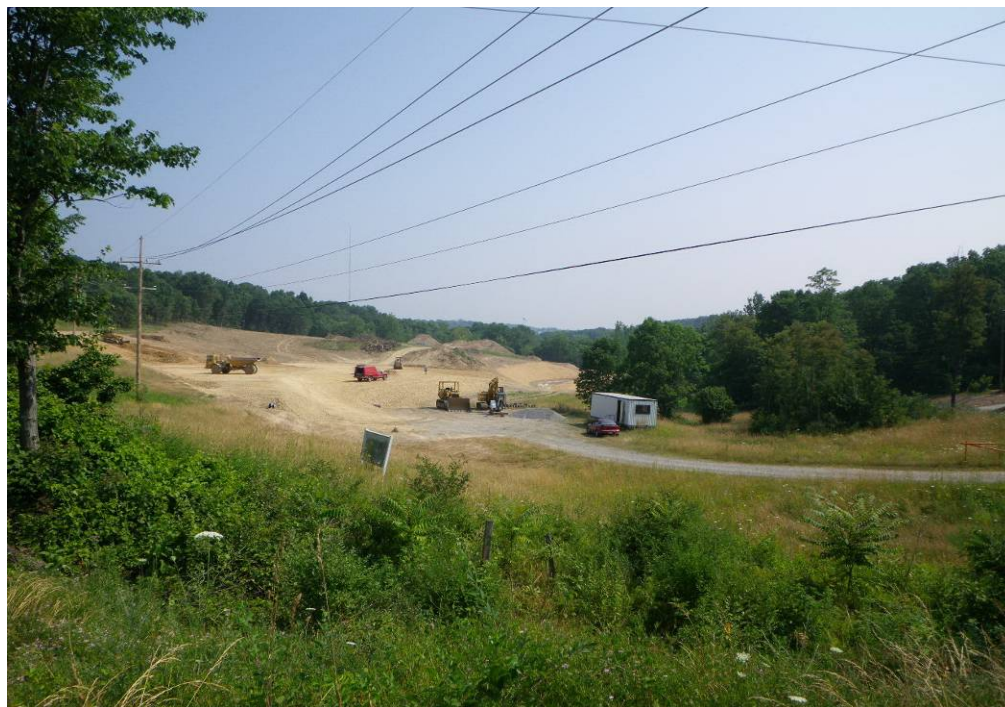
Land use in the watershed area north of the Town of Bath has remained unchanged since 1990 as a large percentage of the land is owned by U.S. Silica Corporation. In the rest of the watershed, population growth has driven land use from agriculture and forest to residential and commercial. Extensive residential development has taken place along the eastern and southern portions of the watershed. This increased development has caused a significant amount of sedimentation in the stream corridor.

**Figure 17:** Construction in the watershed

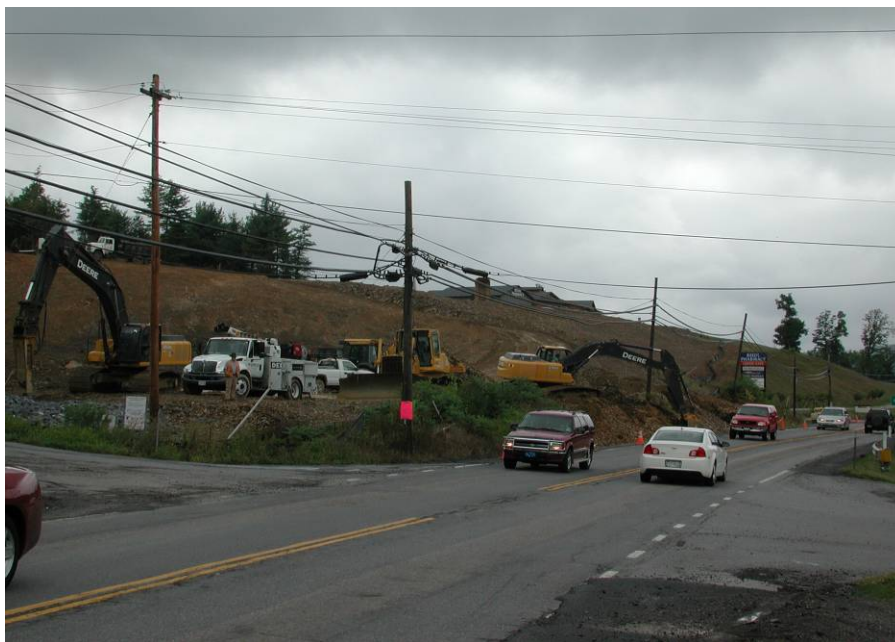
Most commercial development has taken place south of the Town of Bath, along the U.S. Route 522 corridor. There has been construction close to the stream, immediately adjacent to the FEMA-designated floodway (the stream and adjacent 100-year frequency floodplain). This placement of buildings has had a profound effect on the stream corridor and its resilience to outside forces.

**Figure 18:** Construction in the watershed

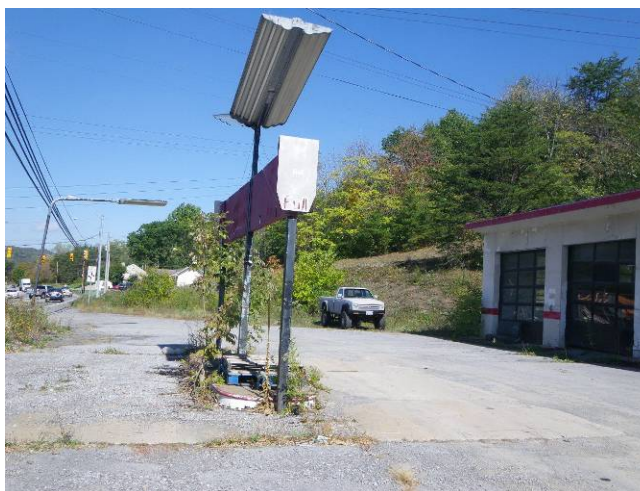
Areas of legacy pollution, which is defined as long-lived pollutants from earlier land uses, are more likely to be found in an urban watershed. (Walsh) In the Warm Springs Run Watershed, there are several areas of legacy pollution. The area adjacent to the train depot on Williams Street is undergoing remediation to eliminate arsenic from the soil. A few yards away on the banks of the Run, there is an area where the Victor Products Company had a refrigeration manufacturing plant. Traditionally, fluorocarbons, especially chlorofluorocarbons were used as refrigerants. Although these chemicals are being phased out due to their ozone depletion properties, residue still remains. Old tanks from many small filling stations in the watershed have not yet been removed. As these tanks decompose, petroleum products find their way to the streams.

**Figure 19:** Legacy pollution in the watershed

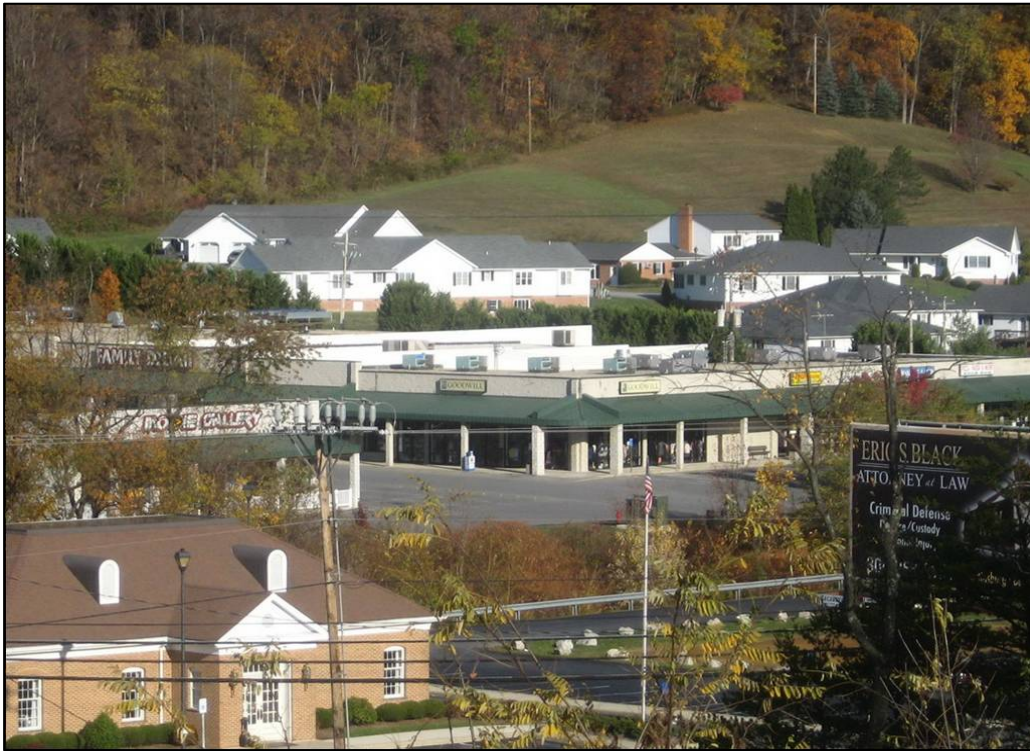
**Figure 24:** Impervious surfaces in the watershed

An impervious surface is a hard surface area that either prevents or retards the entry of water into the soil. Examples include but are not limited to buildings, roofs, patios, driveways, car-ports, parking lots or storage areas. Concrete or asphalt paving, sidewalks and soil surface areas compacted by construction operations, as well as oiled or macadam surfaces are also considered to be impervious.

Impervious surfaces collect particulate matter from the atmosphere, nitrogen oxides from car exhaust, rubber particles from tires, debris from brake systems, phosphates from residential and agricultural fertilizers, and dozens of other pollutants. On a parking lot, for example, one would find buildups of hydrocarbons, bacterial contamination, metals from wearing brake linings, and spilled antifreeze.

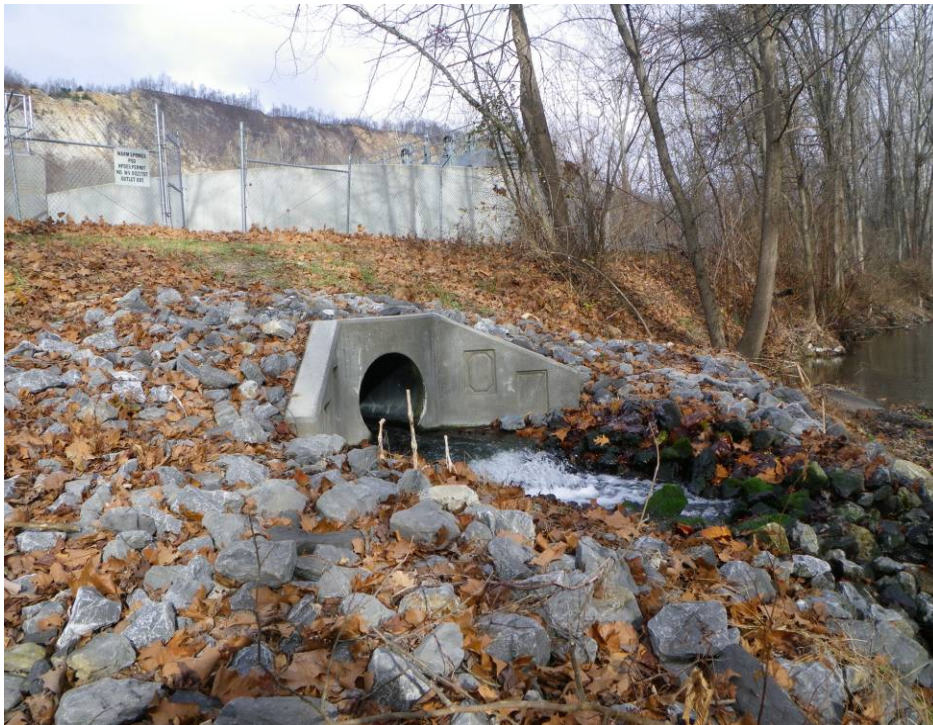
**Figure 25:** Outfall pipe from the WSPD sewage treatment plant into the Run

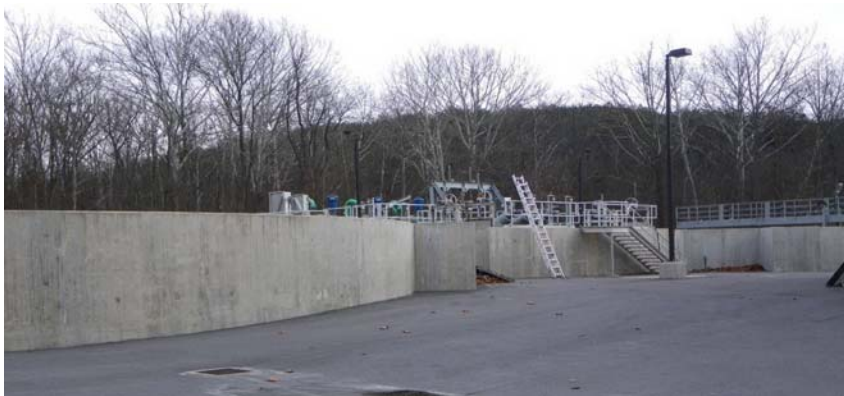
**Figure26:** Treatment basins at WSPSD wastewater treatment plant

Prior to upgrades to the WSPSD system, there was extensive infiltration of the wastewater collection system during storms. Large storms would overwhelm the capabilities of the sewage treatment plant causing untreated effluent to flow into the Run. Recent upgrades have corrected most of the problems in the Town of Bath.

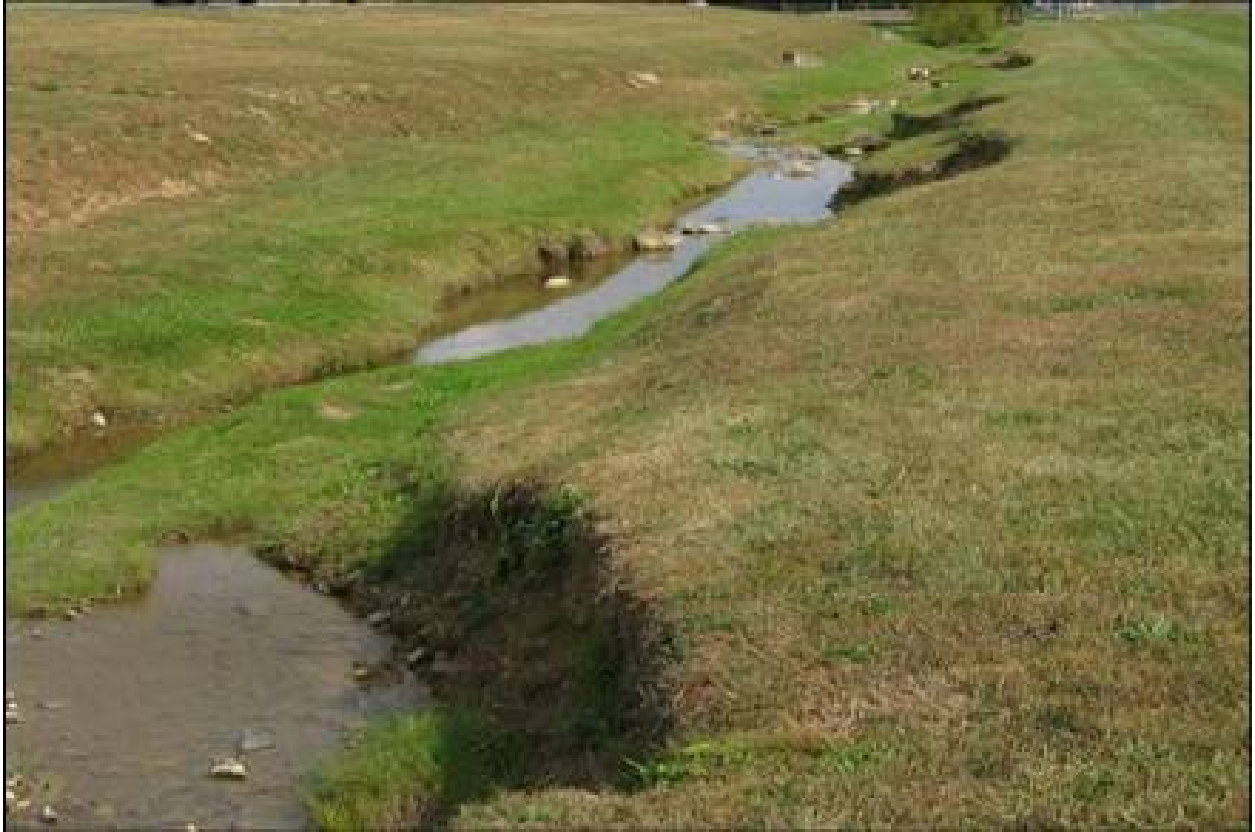
The riparian buffer of the Warm Springs Run Watershed is highly impaired. In the section running from Winchester Grade Road to Jimstown Road, for example, there are virtually no areas where the banks of the Run are protected by stands of native trees and shrubs. There are more parking lots than lawns in this portion of the watershed, and where there are grassy areas they are almost always mowed right to the edge of the stream. In some areas, asphalt parking lots end right at the banks of the Run. In other places the Run is channelized, or lined with riprap, both of which destroy the riparian buffer.

**Figure 28:** Grass mowed to the edge of the Run

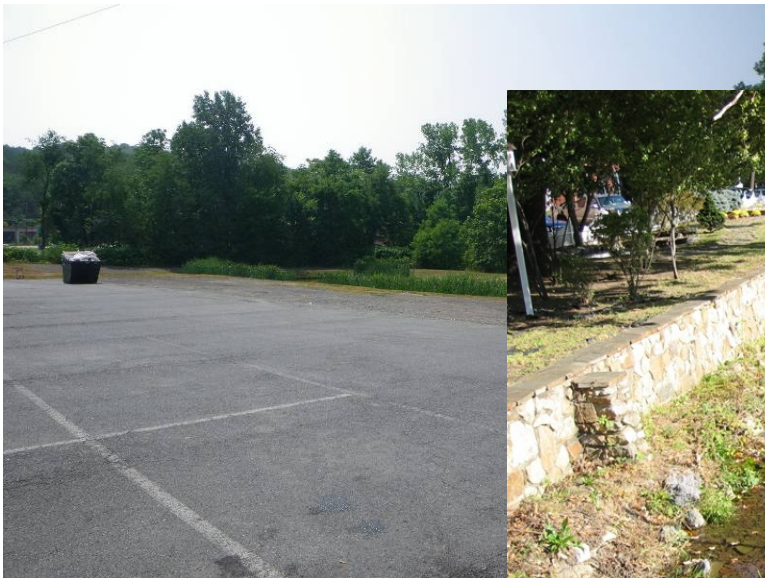
**Figure 29:** Parking lots paved to the edge of the Run

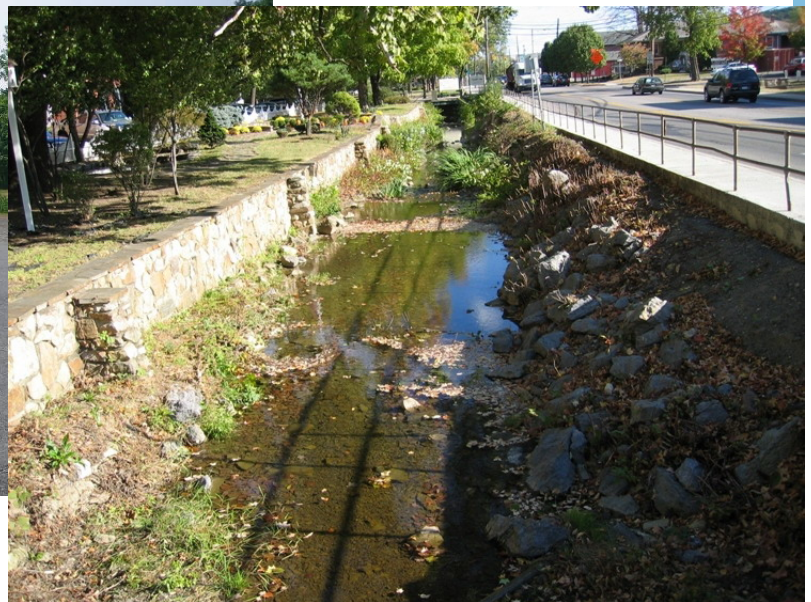
**Figure 30:** The Run channelized on one side, lined with riprap on the other side

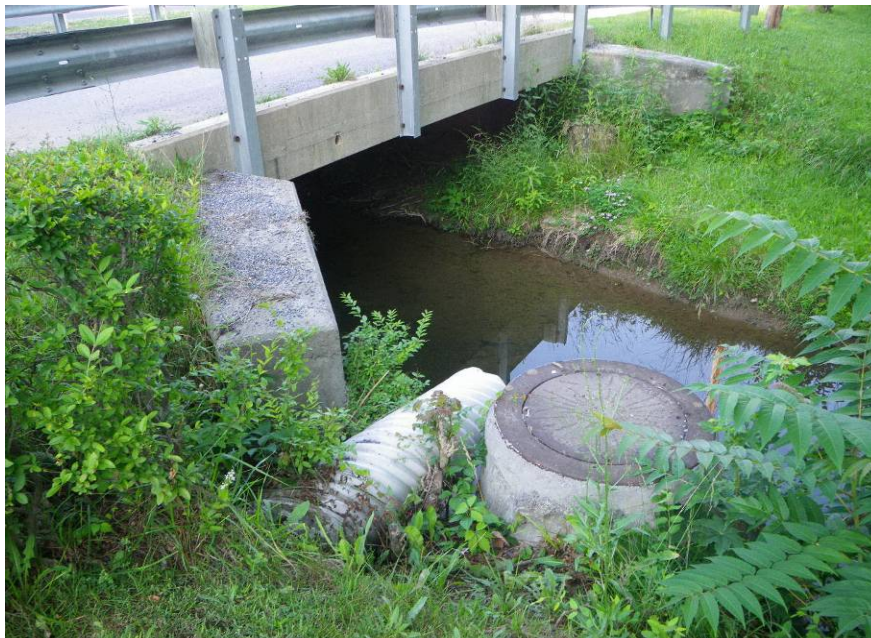
In urban watersheds, at least two factors influence the geomorphology of a stream. The first factor is structures such as bridges, culverts, railways and dams in the stream corridor, and changes on the streambank such as walls or riprap. These structures can interrupt the stream corridor, alter local stream hydrology and impact bank stability.

**Figure 31:** Structures in or near the Run affect its geomorphology

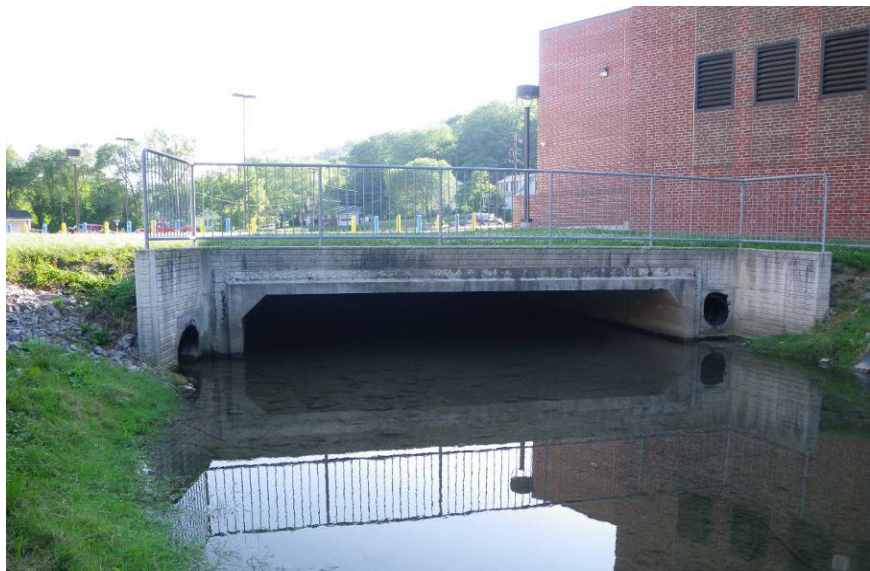
The situation at Berkeley Springs High School is exacerbated by several features. The first is the pronounced lack of a riparian buffer upstream by Widmyer Elementary School. As stated earlier, riparian buffers filter and slow the introduction of sediment into a stream. Second, the lack of a riparian buffer causes erosion of the streambank itself, which also increases sediment load in the Run. Third, sediment is scoured from the streambed where there are raised manholes, culverts, or bridges; this sediment is then deposited downstream.

**Figure 32:** Closed culvert increases the sediment load, exacerbating flooding

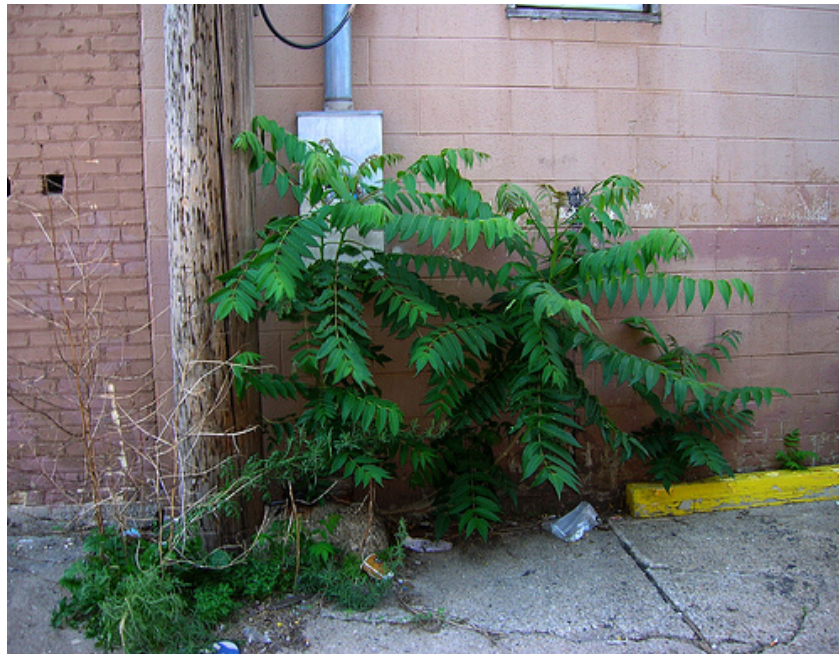
**Figure 33:** Invasive species such as tree of heaven crowd out plants that are native to the watershed. Tree of heaven can also crack foundations.

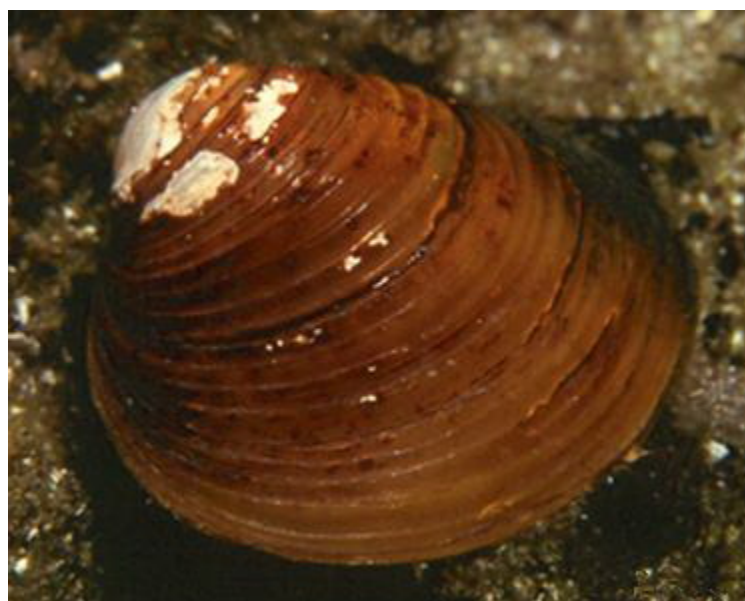
**Figure 42:** Asian clam

Particular mention should be made of the presence of the Asian clam (*Corbicula fluminea*). The Asian clam is a native of temperate and tropical Asia. The first record of this species in the United States is from 1938 in the Columbia River in Washington. Currently, the Asian clam occurs in 38 states and the District of Columbia. These mollusks are filter feeders that remove particles from the water column. They can be found at the sediment surface or slightly buried. Their ability to reproduce rapidly coupled with low tolerance of cold temperatures, can produce wild population swings. Densities of several thousand clams per square meter have been documented.

High concentrations of Asian clams have been known to clog water intake pipes used in power and water plants, causing millions of dollars worth of damage. This species also alters benthic substrates and competes with native mollusks for limited food and space resources. The 2007 Stream Corridor Assessment documented Asian clams from the mouth of Warm Springs Run upstream to the U.S. Silica plant (but not upstream of the low head dam at the plant).

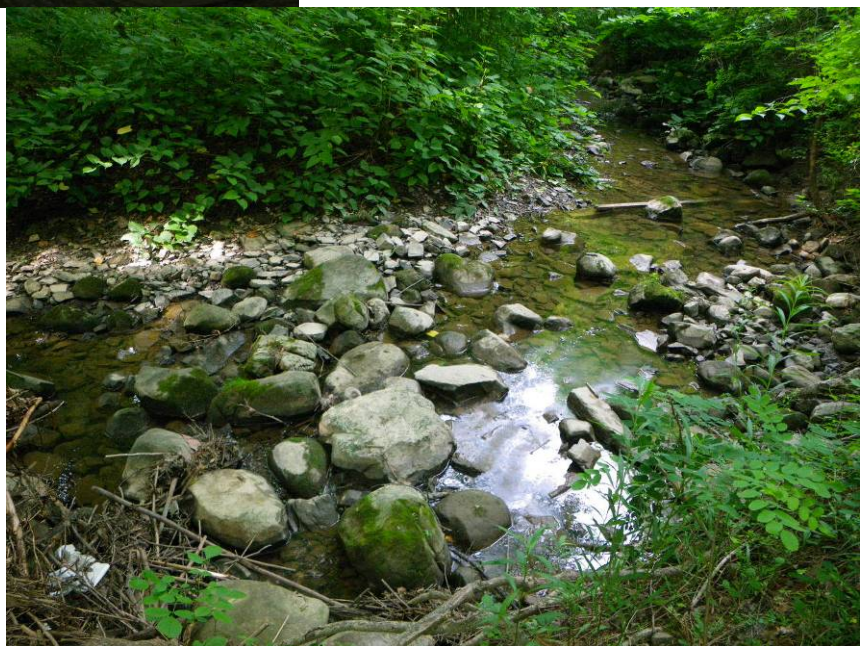
**Figure 45:** Site 2

The reach was in a mostly wooded area, with some large trees. The streambed contained a lot of fine sediment and the banks were moderately stable, with evidence of erosion from previous heavy flows.

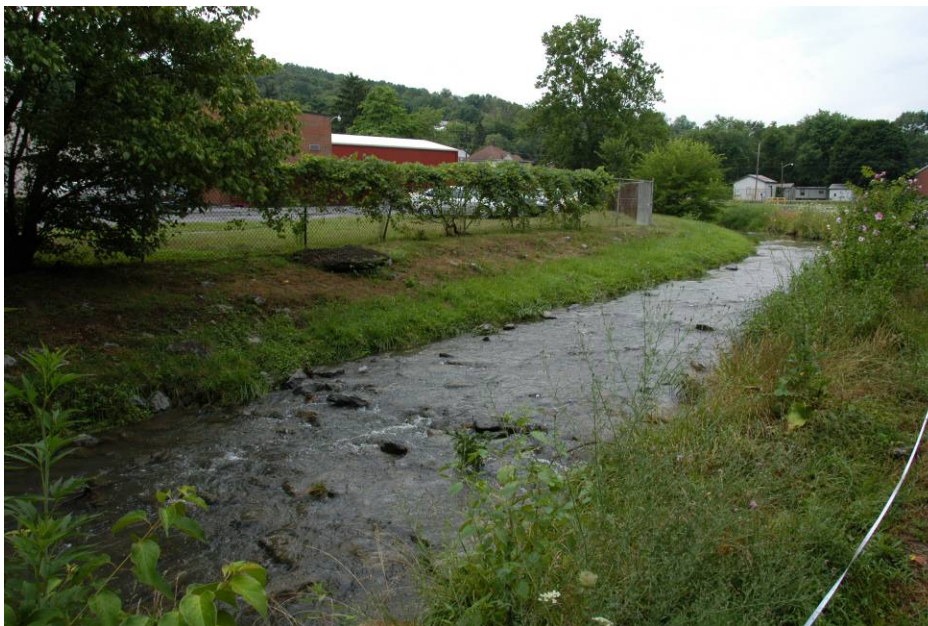
**Figure 47:** Site 4

wall, but no drainage or odor was noted from either pipe. There were only a few trees and these were on the east side of the reach. A 25 foot long, metal and wood pedestrian bridge was located 82 meters upstream from the start of the reach. A double-lane concrete bridge was located approximately 100 feet above the upper end of the reach; the paved road received moderate, mostly residential traffic.

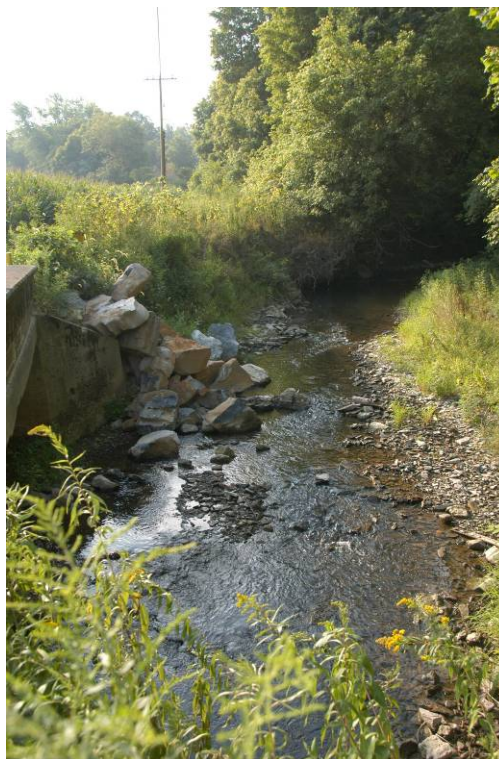
**Figure 48:** Site 5

Site 5 is located at Airport Road, Hancock, WV. The GPS Coordinates are N39° 41.602,' W78° 10.528.'

The reach is located near a small CSX railroad yard that services the U.S. Silica plant north of the Town of Bath. Cornfields were seen within 10-30 meters of the streambanks, on both sides of the reach, below the bridge. The Run flowed under an old single lane concrete bridge, located in approximately the center of the reach. Vehicle traffic on the bridge, which is used to access a local airport, is limited, as the bridge has a locked gate. The water in the reach was higher than expected considering the lack of rain the previous two months; this may be due to the fact that it is located several miles below the Warm Springs Public Service District waste-water treatment facility. There were a few large trees at the upper end of the reach, but the streambanks on the remainder of the reach contained mostly shrubs and flowering plants, including some purple loosestrife and a significant amount of Japanese knotweed on the west streambank, both above and below the bridge. The streambanks above the bridge showed evidence of significant erosion, based on the level of tree root exposure.
