# **Warm Springs Run Stream Corridor Assessment**

**Kieran O'Malley**

**Commissioned by the  
Morgan County Purple Loosestrife Task Force**

**October, 2007**

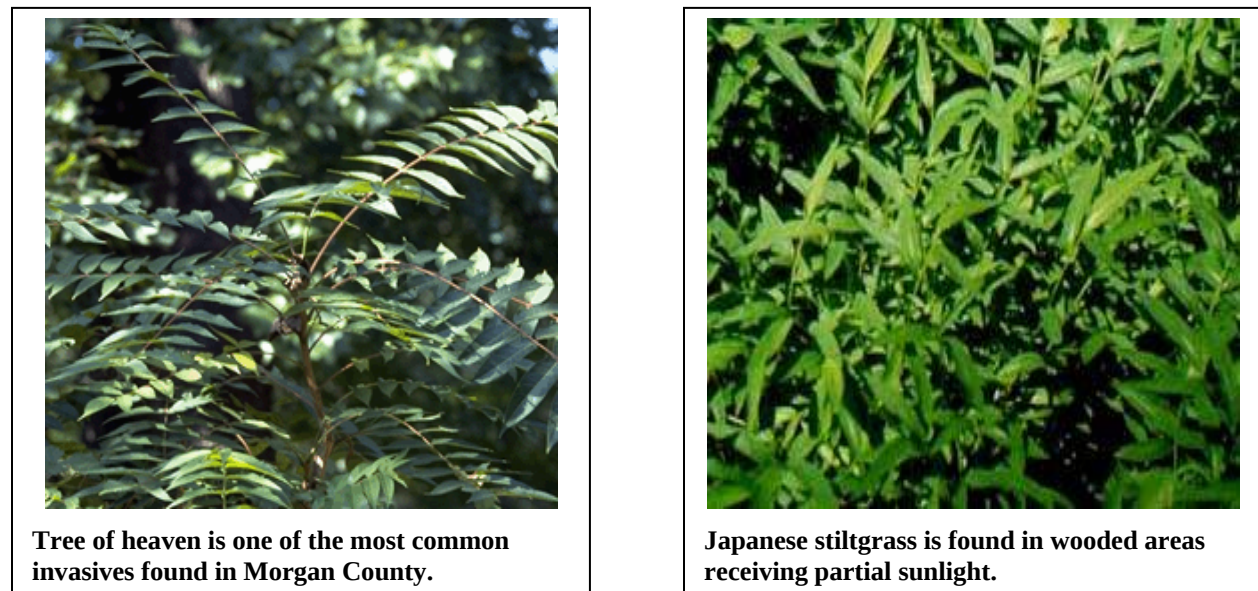
**Figure 4. Examples of common invasive plants found in the Warm Springs Run Watershed.**

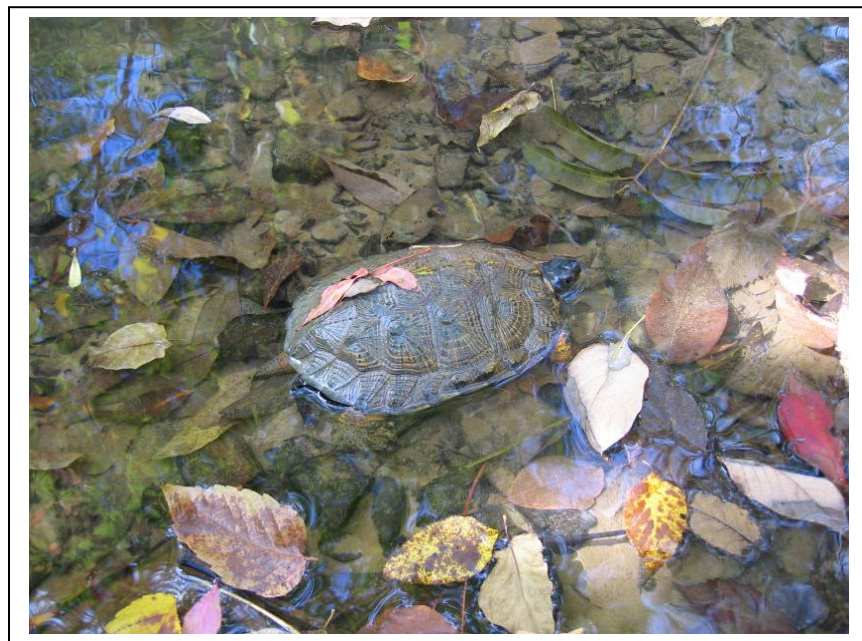
**Figure 9.** Despite the degraded quality of the stream, Warm Springs Run is utilized by many species of wildlife, like this wood turtle.
